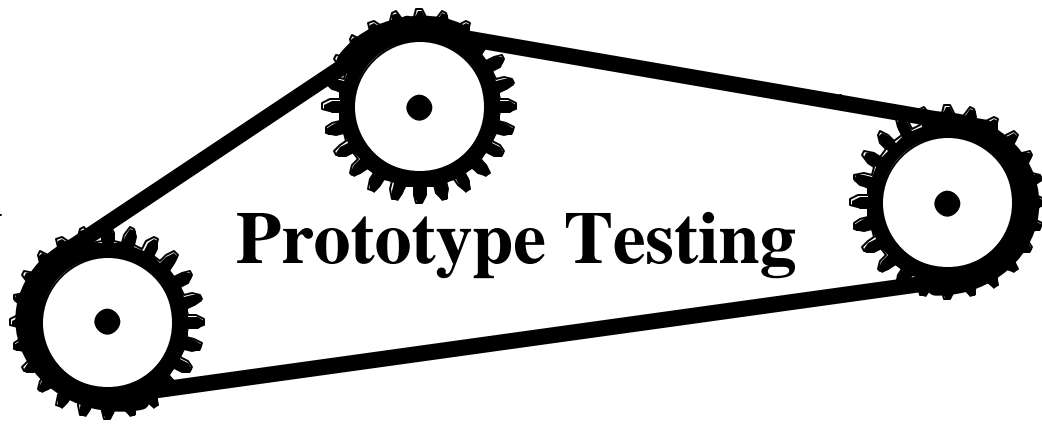
To begin testing of the trolley system, a motor with 100 oz.-in. of torque was connected to the trolley. The purpose for using this motor was to physically test the trolley system for the amount of motor torque needed. With the motor on the trolley it was then connected to a power source and turned on. It was found that the motor had enough torque to drive the unloaded trolley. However, when weight was added to the trolley the motor had a very difficult time starting up and continuing movement. This proved that a 100 oz.-in. motor would not be sufficient. Therefore, a motor with 480 oz.-in. of torque was chosen. This motor was tested by adding weight to the trolley and starting it from rest as well as driven continuously. The motor proved to have enough torque to drive the loaded trolley easily.

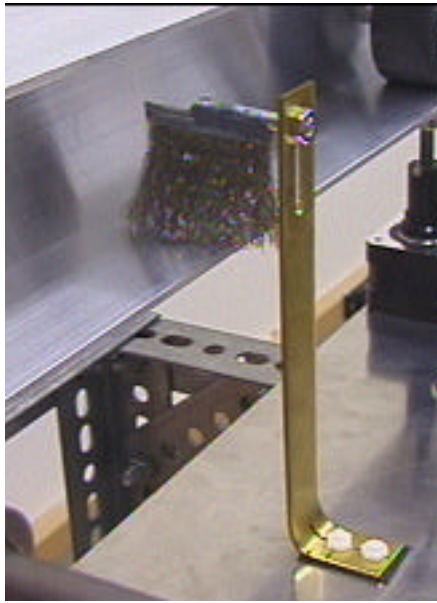
To prove that the system can be truly wireless, testing on the power connection method was performed. To do this, the electrically isolated tracks were connected to a power supply. One track was connected to the positive lead and the other to the negative. The trolley power connection brushes were adjusted to rub along the tracks properly and the power was turned on. The trolley started moving immediately. This was exactly what was desired to occur making the trolley system a success up to this point.

*Figure 7.3: Power Connection Arm and Brush*

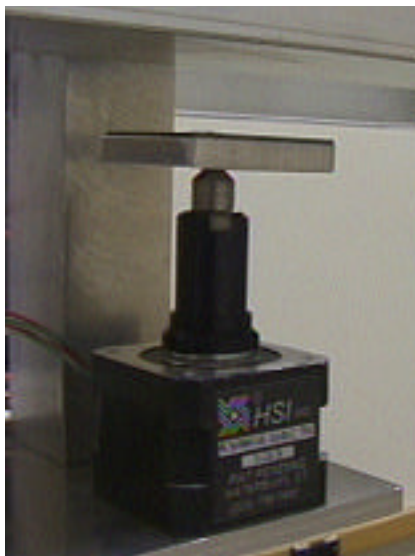
After finding that the trolley drove well with the mounted laser detector, the next test was to find out how the system operated while in a static position. To do this, the static constraint system was employed, locking the system into position. The first test was a vibration test. The hanging laser detector mount was struck numerous times on different sides to simulate a wind gust. The vibration that the laser detector experienced was minimal. The vibration was found to damp out after approximately one second. Next the tracks were vibrated with different amplitudes causing the trolley to vibrate in response. Again, the vibration that the laser detector experience was minimal and damped out quickly.

*Figure 7.6a: Static Constraint System Disengaged*

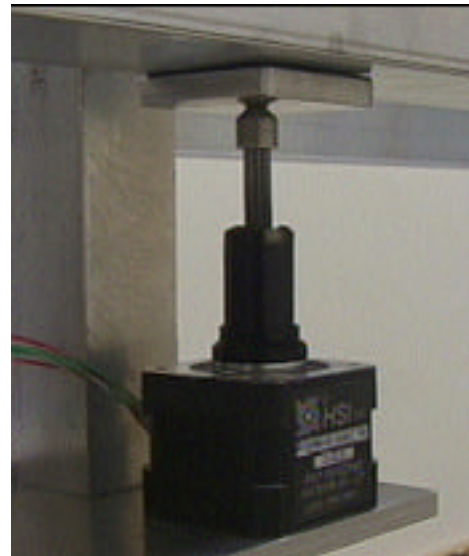
*Figure 7.6b: Static Constraint System Engaged*

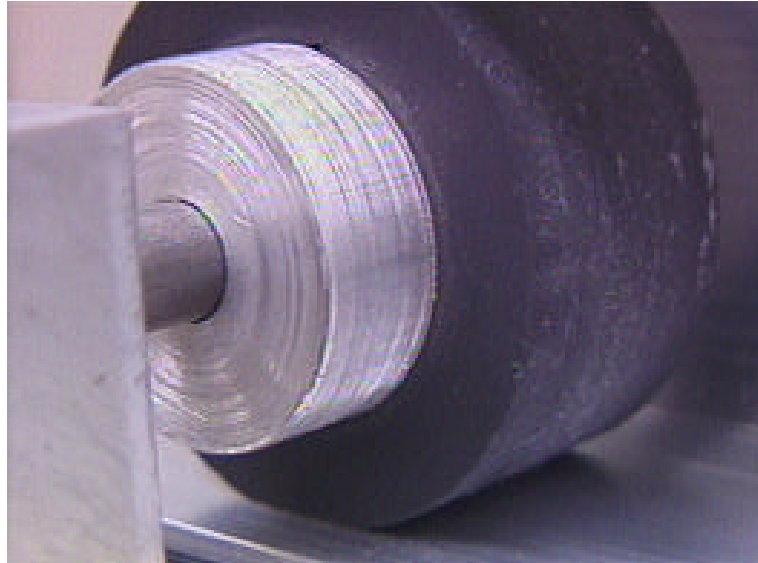
Since the linear actuators are somewhat strong, a wheel deformation test was also performed. For this test the linear actuators were engaged against the tracks to lock the trolley in place. This caused the wheels to deform slightly due to the somewhat large applied force. The trolley system was kept locked in place with deformed wheels for just over two weeks. The linear actuators were then disengaged and the trolley was driven. It was found that there was no noticeable permanent deformation of the wheels. With

permanent wheel deformation, the trolley will experience a bumpy ride. This is not detrimental but is slightly undesirable.

*Figure 7.7: Deformed Wheel*

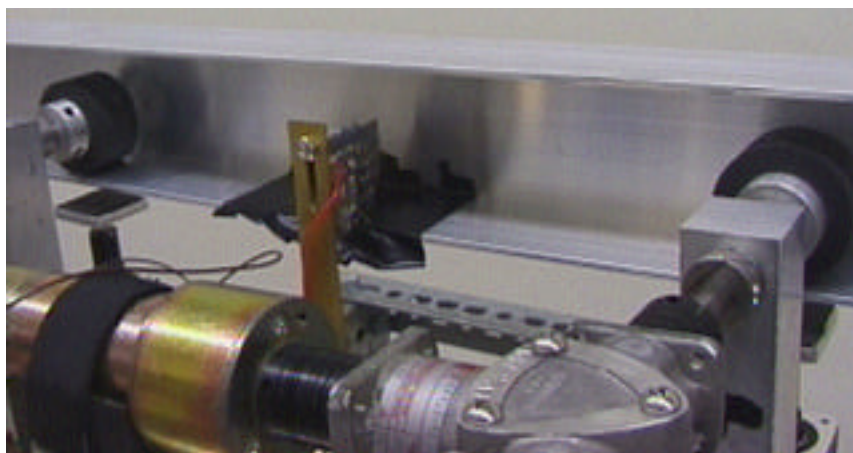
*Figure 7.8b: Trolley Overcoming Discontinuous Section Using Backup Batteries*
